DEPARTMENT OF TRANSPORTATION

Contract #: 04-0120F4Cty: SF/ALA Rte: 80 PM: 13.2/13.9File #: 69.28**WELDING INSPECTION REPORT****Resident Engineer:** Pursell, Gary**Address:** 333 Burma Road**City:** Oakland, CA 94607**Report No:** WIR-003371**Date Inspected:** 24-Jul-2008**Project Name:** SAS Superstructure**OSM Arrival Time:** 1400**Prime Contractor:** American Bridge/Fluor Enterprises, a JV**OSM Departure Time:** 2300**Contractor:** Zhenhua Port Machinery Company, Ltd (ZPMC), Changxing Island **Location:** Shanghai, China**CWI Name:** Chen Chih-Ming/Li Jia**CWI Present:** Yes No**Inspected CWI report:** Yes No N/A**Rod Oven in Use:** Yes No N/A**Electrode to specification:** Yes No N/A**Weld Procedures Followed:** Yes No N/A**Qualified Welders:** Yes No N/A**Verified Joint Fit-up:** Yes No N/A**Approved Drawings:** Yes No N/A**Approved WPS:** Yes No N/A**Delayed / Cancelled:** Yes No N/A**Bridge No:** 34-0006**Component:** OBG side, bottom and deck panels and tower**Summary of Items Observed:**

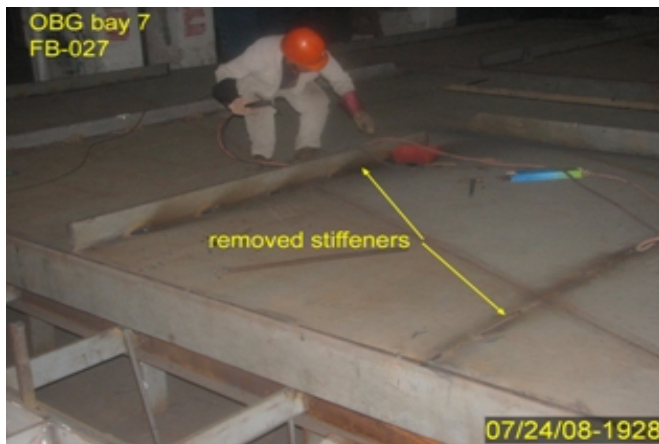
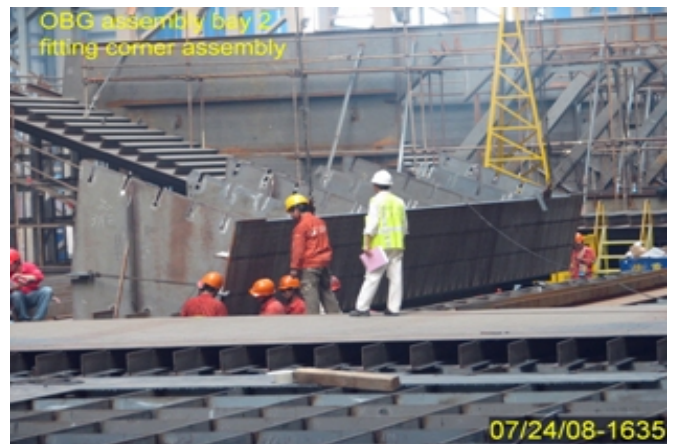
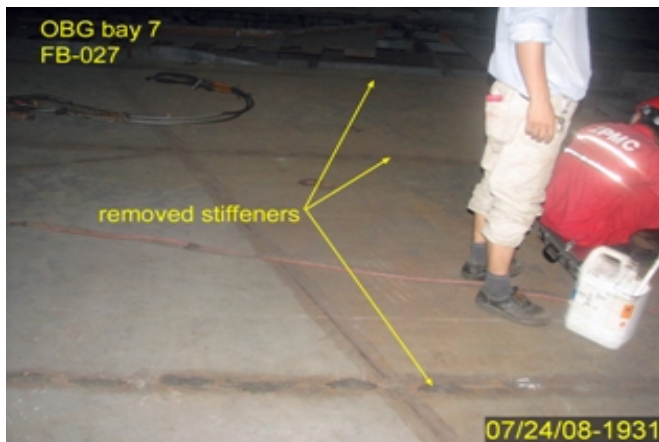
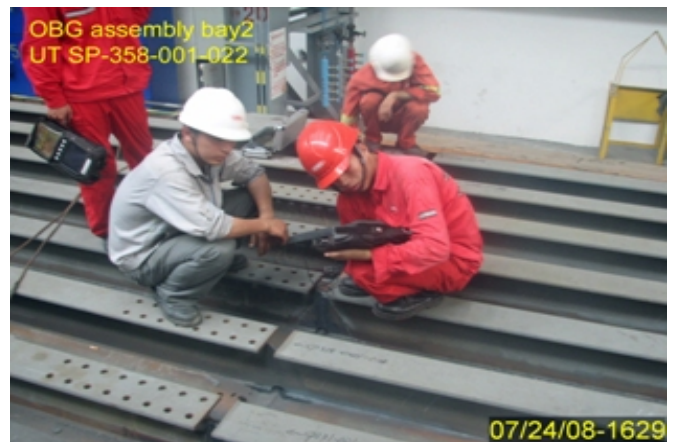
QA observed ZPMC qualified welding personnel SMAW tack welding SEG-017-002 DP-260 to DP-270.

QA observed ZPMC personnel fitting diaphragm plates inside corner assembly. No part ID found.

QA observed ZPMC personnel fitting component LD-3A W3 between PP-027 and PP-026 on OBG section 4BW.

Other general observations include ZPMC personnel fitting and welding OBG east fixture, OBG temporary support columns, grinding and weld bevel prep on various OBG components.
